From Stench to Serenity: How We Revived a 5-Year Dead STP

Jayanti Nagari 3, Nagpur · Residential Apartments & Row Houses · April 2026

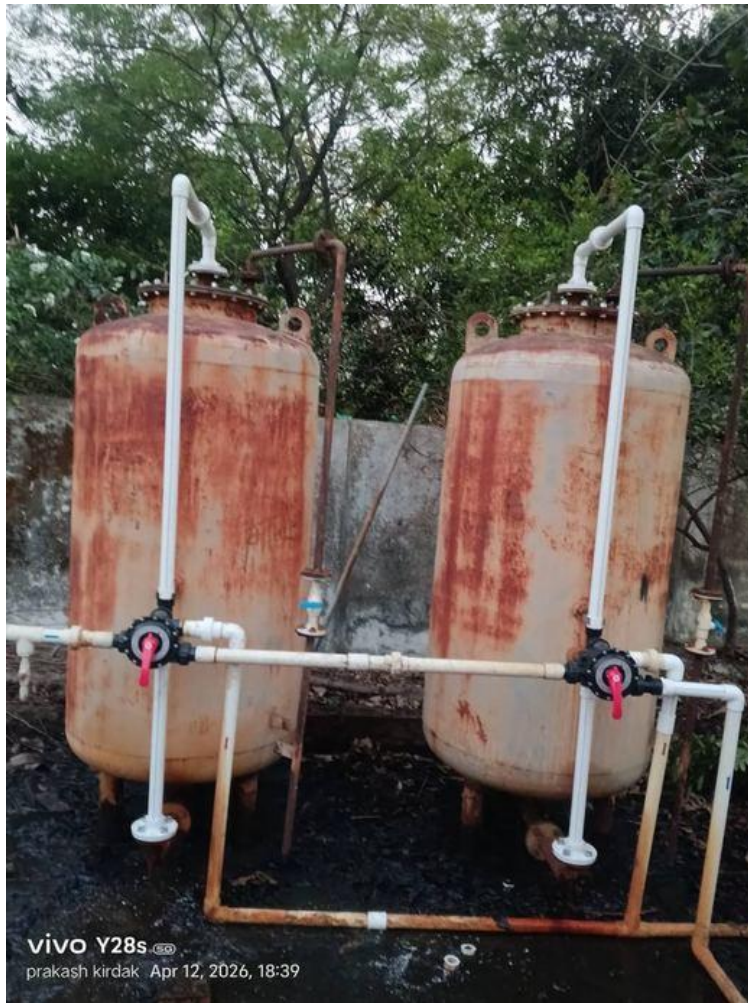
Before: Two heavily corroded MS sand filter vessels — 5 years of complete neglect, rust and waterlogged base

The plant itself had deteriorated severely across every component. The MS (mild steel) sand filter and carbon filter vessels were covered in heavy rust corrosion — orange-red rust had eaten through the surface on all sides. Pipelines were broken and disconnected. The multiport valve — a critical component controlling the filtration and backwash cycles — had seized completely and been removed, lying useless on the ground.

**Mechanical Overhaul** Both sand filter and carbon filter MS vessels — complete surface preparation, rust treatment, priming and full repainting in professional blue finish

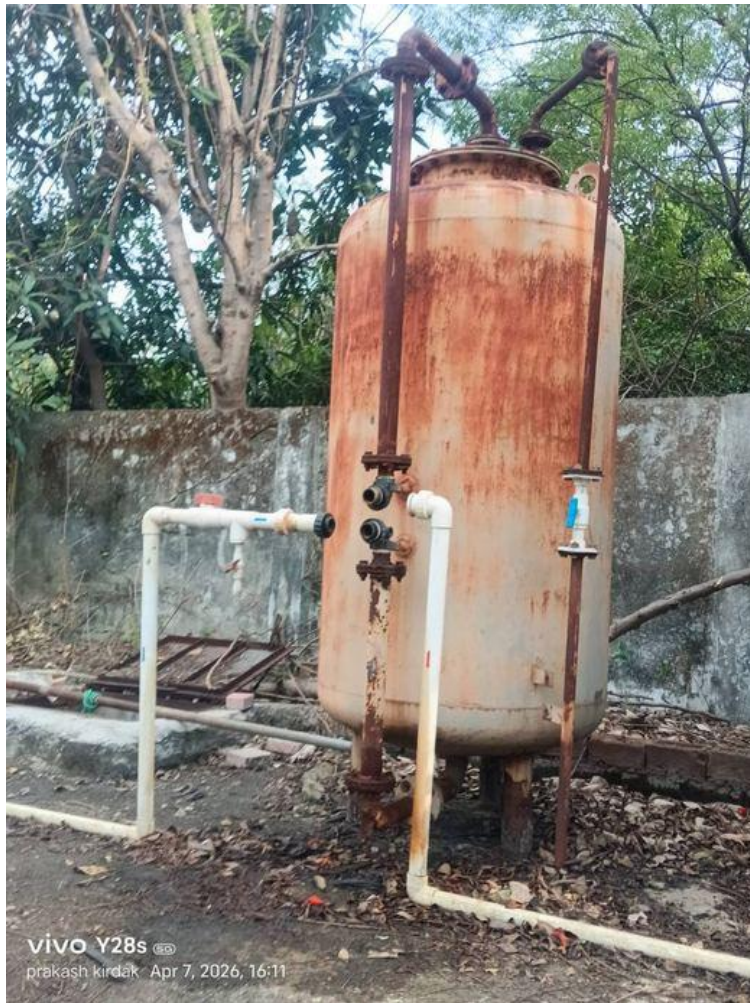
Before: Damaged pipeline connections and a severely corroded single filter vessel — structural integrity fully compromised

**Pipeline Network** Complete replacement of all frontal pipework, valves, fittings and connections — new UPVC and MS pipelines installed throughout

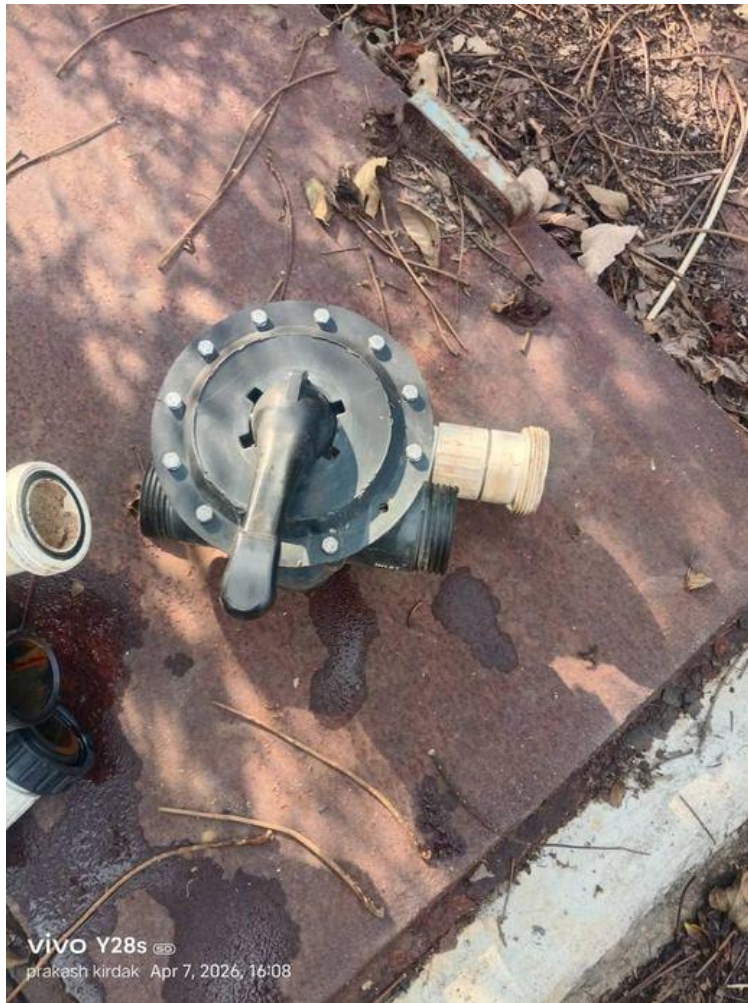
Before: The failed multiport valve — cracked and non-functional, lying on the ground. This single component failure cascaded into total plant shutdown.

**Multiport Valve Replacement** Failed multiport valves removed and replaced with new properly rated valves — restoring backwash and filtration cycle control

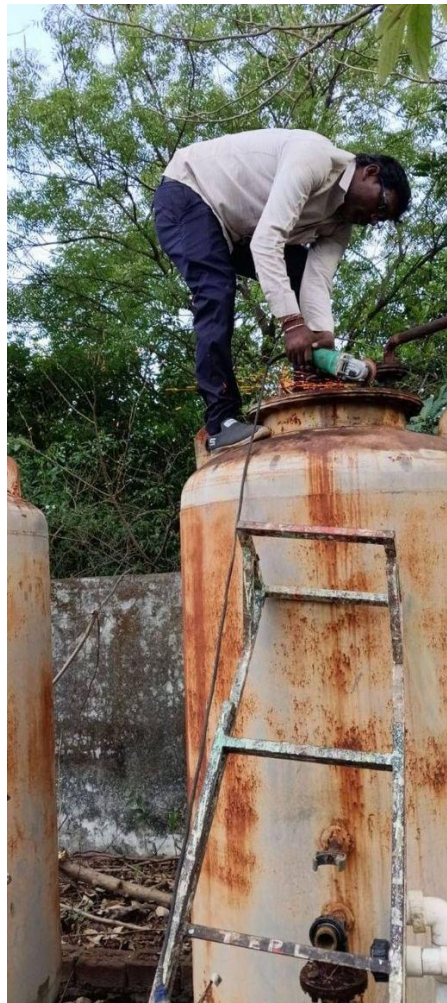
During: WCT technician on top of seized vessel — cutting open the backwash flange with an angle grinder. Sparks flying — this is the kind of hands-on skilled work most contractors avoid.

**Seized Flange Access** Cutting open severely seized backwash flanges using angle grinding — critical for accessing and replacing internal media

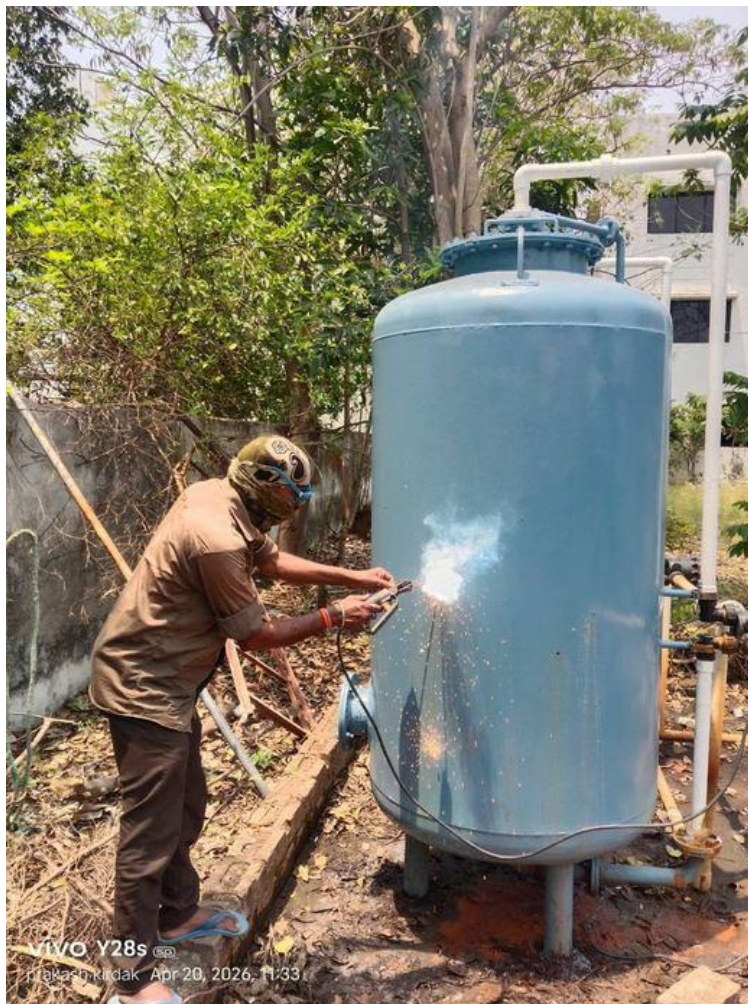
During: Welding work on the freshly painted blue carbon filter — new pipeline connections being fitted. The transformation from rust-red to clean blue is already dramatic.

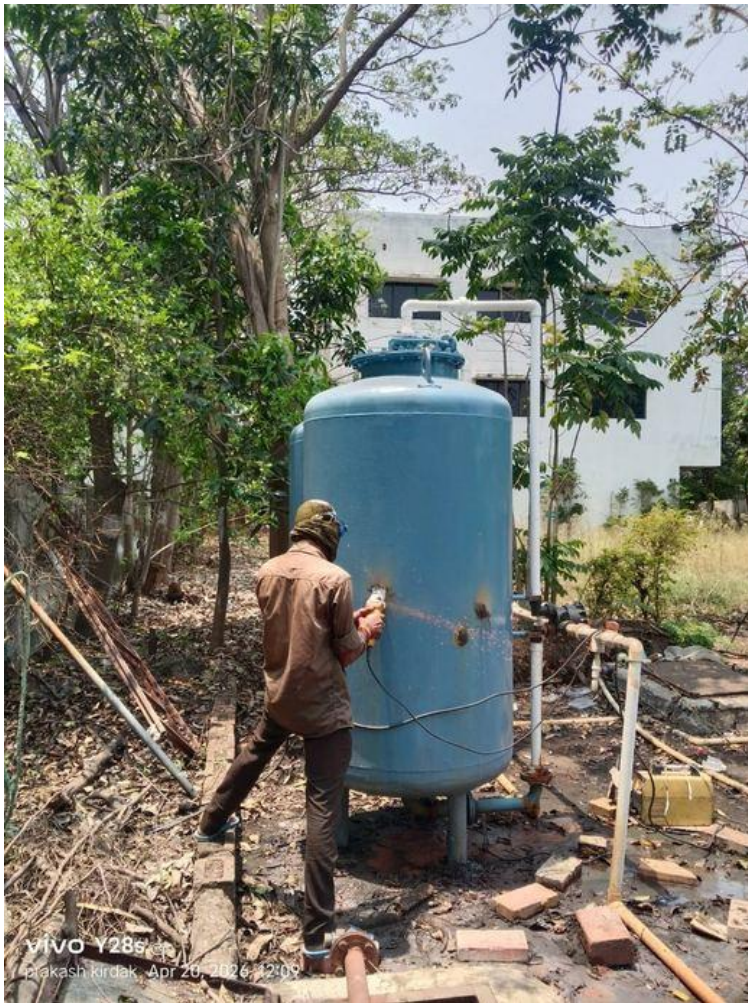
During: Angle grinding and surface preparation work on the second filter vessel — achieving the clean blue professional finish.

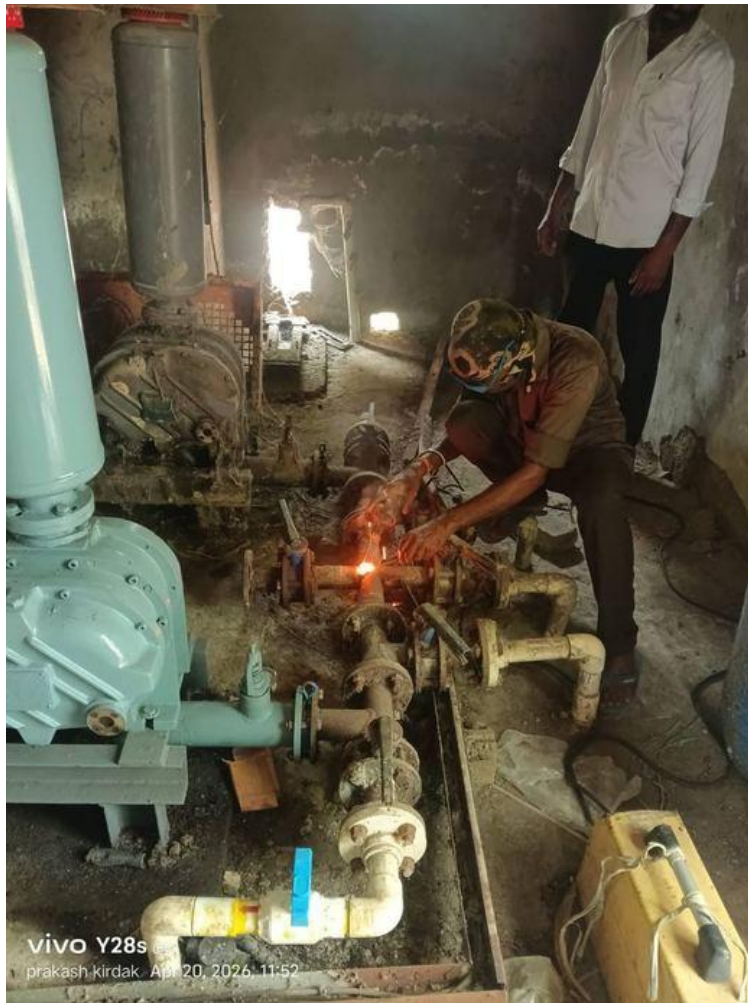
During: Inside the blower room — new lobe blower installed (left), technician welding the new pipeline manifold connections. This blower is essential for biological aeration.

🌀 **New Lobe Blower** New lobe blower installed in the blower room — critical for supplying aeration air to the biological treatment chamber

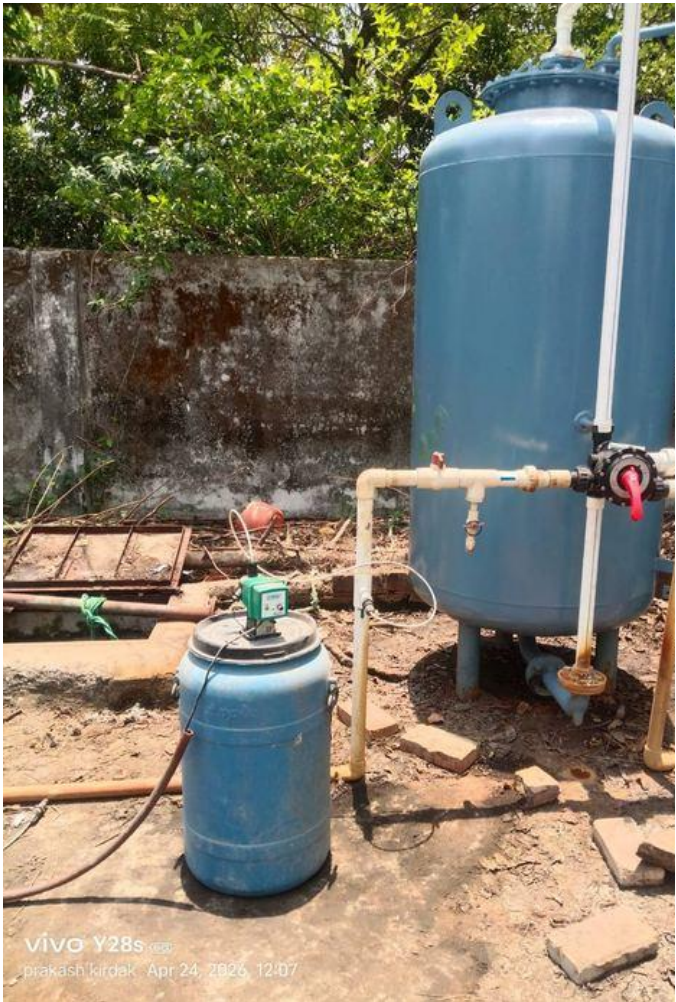
Culture dosing system — biological process restarted

🔑 **Culture Dosing System** New biological culture dosing system installed — seed culture added to restart the biological treatment process from scratch

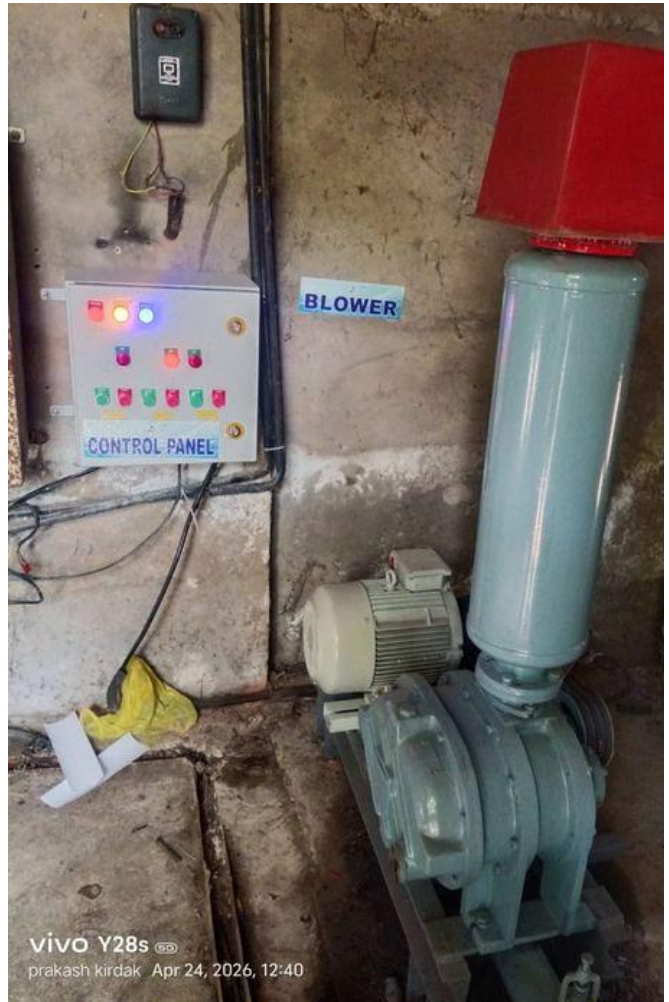
New control panel & blower — operational and labelled

🔌 **Control Panel** New electrical control panel installed with proper switches, indicators and labelling — enabling reliable operation and monitoring

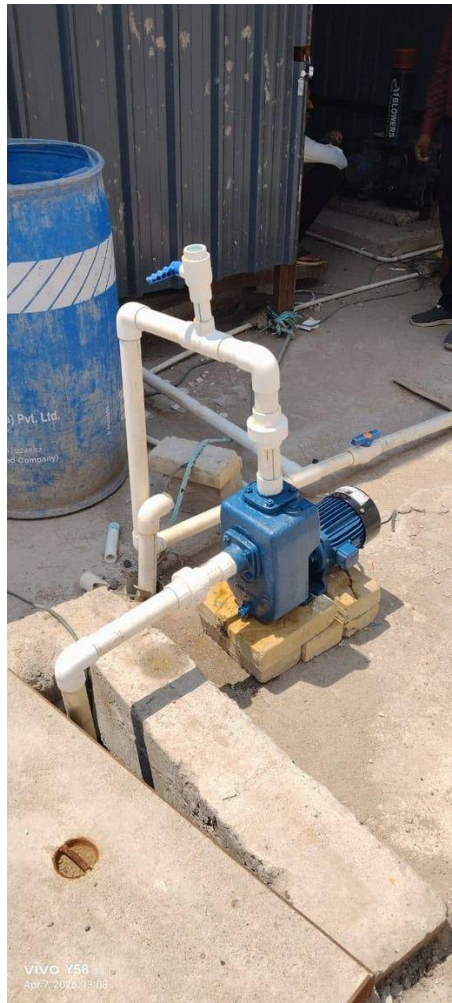
New collection tank pump installed — treated water can now be pumped for garden reuse

💧 **Collection Tank Pump** New pump installed for the treated water collection tank — enabling treated water to be pumped for reuse

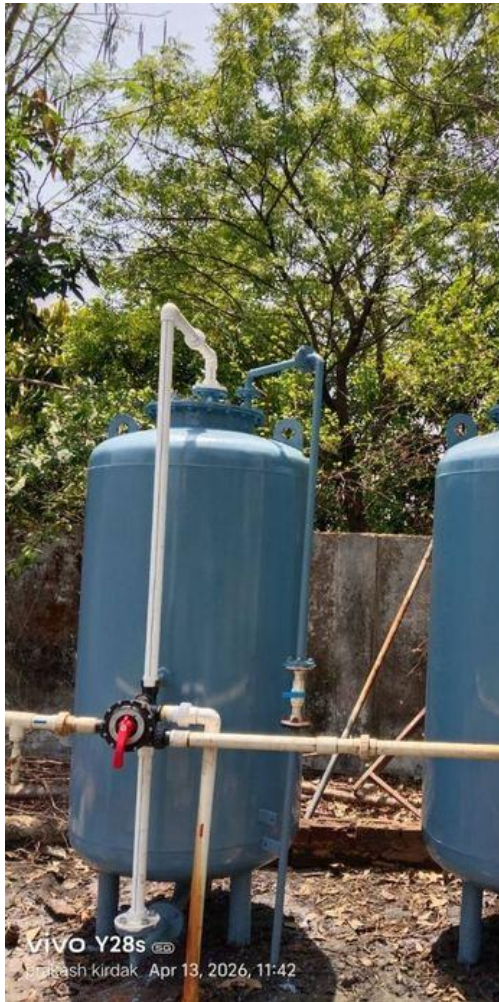
Twin filter vessels — fully painted, valved & commissioned

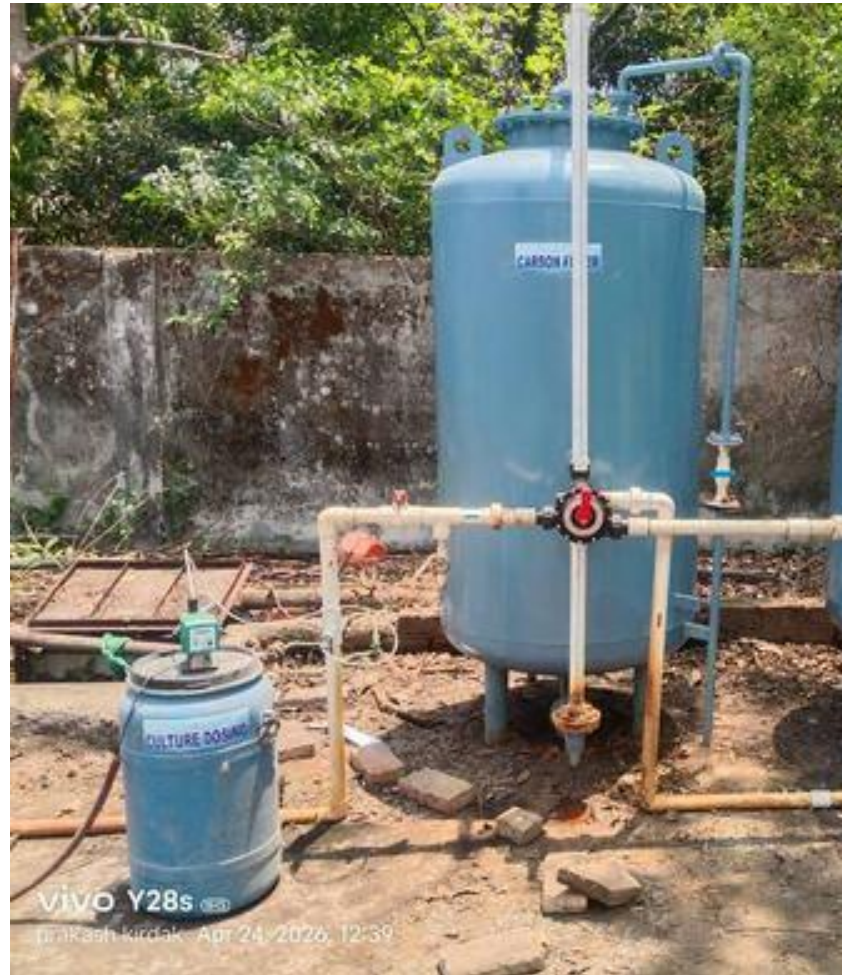
Sand & Carbon filters — ready for operation

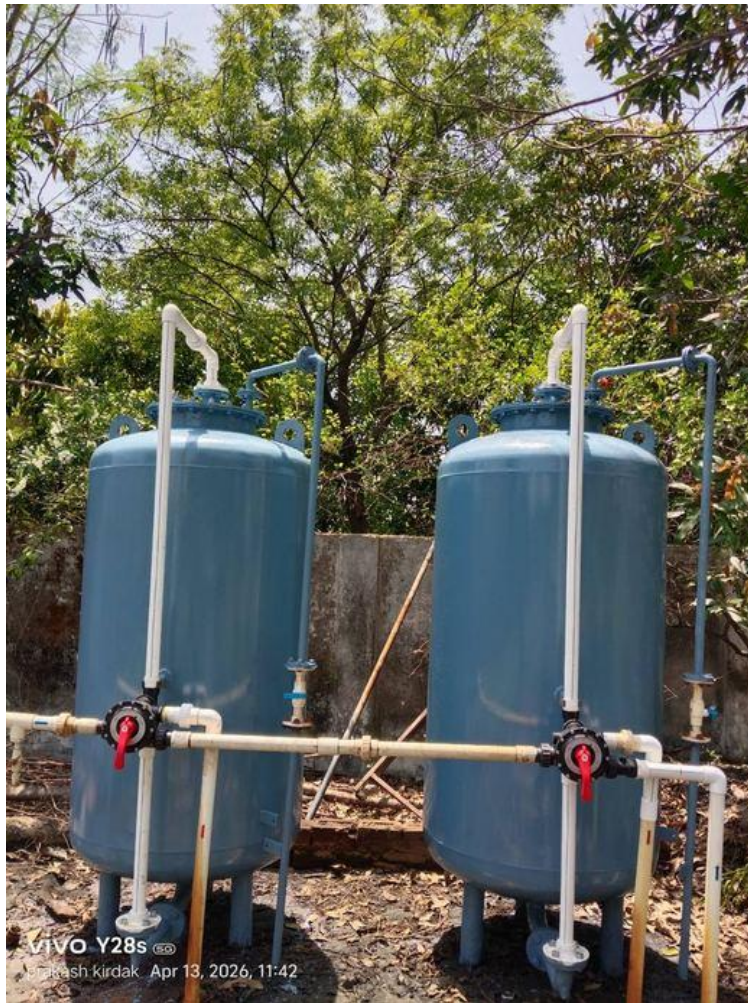
The complete STP — Carbon Filter + Sand Filter + Culture Dosing System — all fully operational and labelled. A professional installation. April 2026.

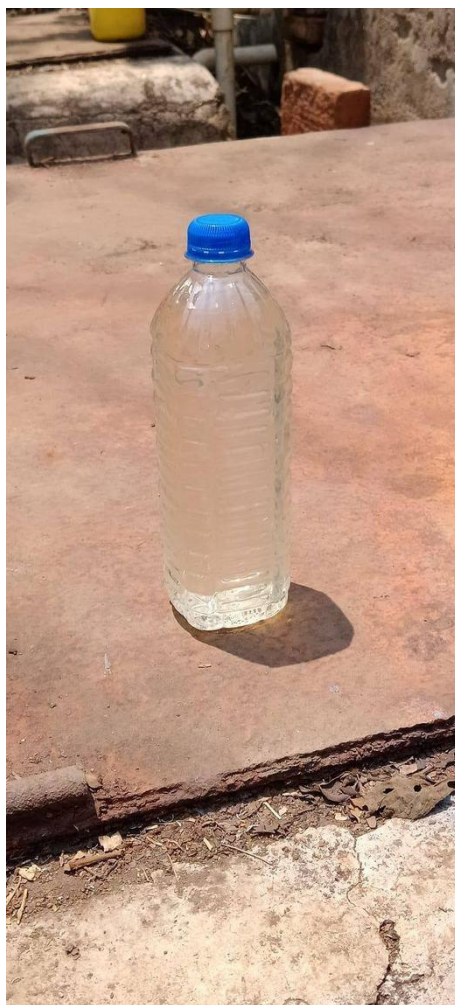
The proof — treated water collected from the revamped STP. Clear, odour-free, meeting irrigation quality standards. This came from a plant that was dead just three weeks earlier.
